Report No. 0270-07-17309

Testing and Examination of Pipe from
Dixie Pipeline Company's
12-inch Hattiesburg, MS to Demopolis, AL Pipeline

T. V. Bruno

March 30, 2007

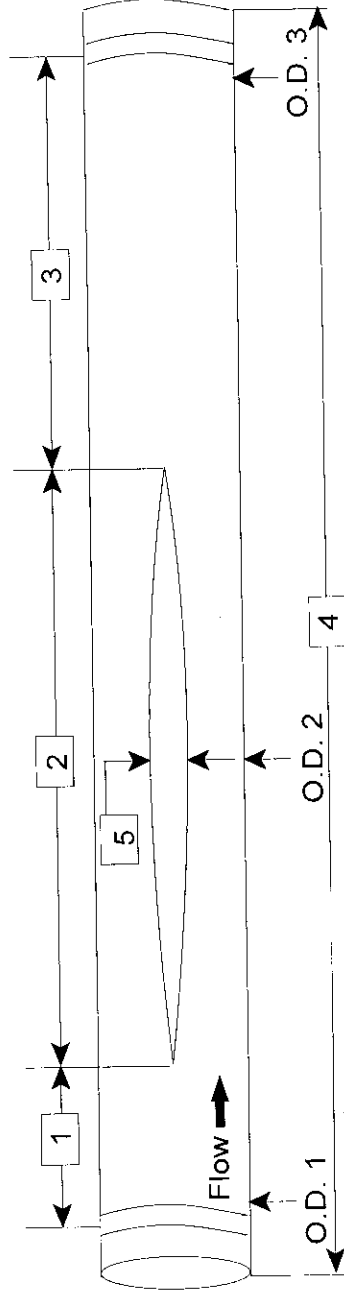
Figure 3

Failure pressures and dimensions for the third seven burst tests.

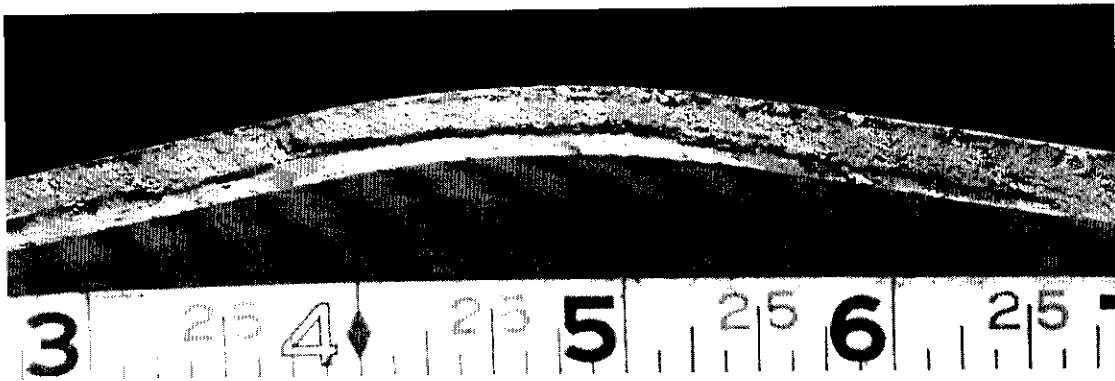
Figure 5

Close-up view of the hook crack at the failure origin.

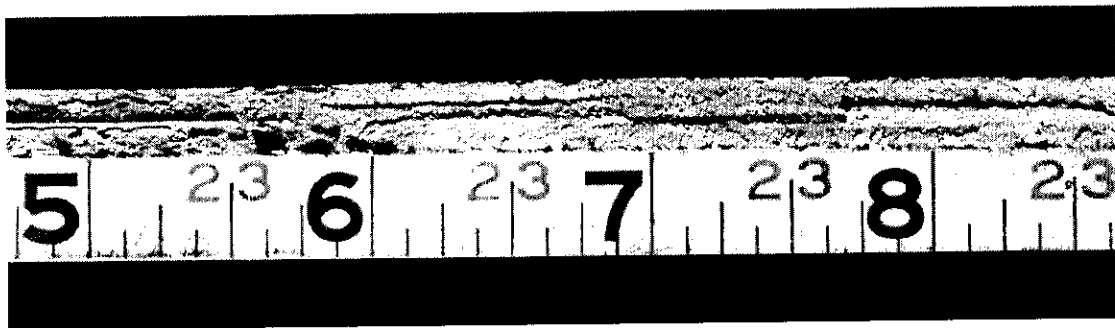
Figure 6

Close-up view of the hook crack at the reported USCD indication.

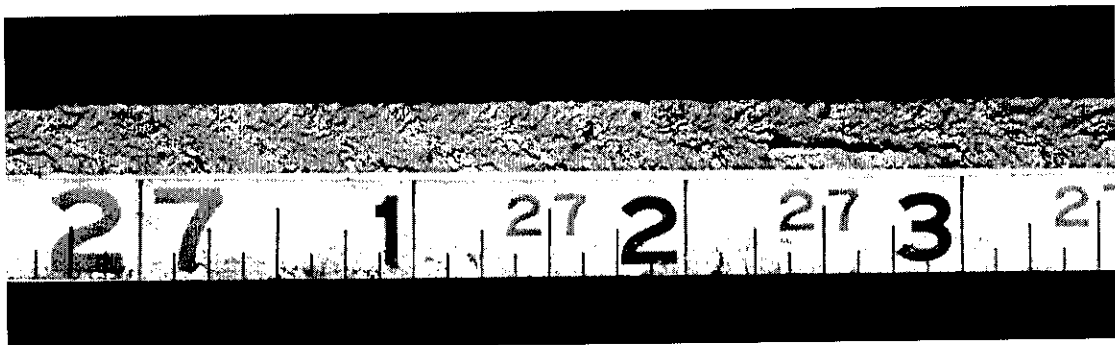
Figure 7

Typical hook cracks upstream from the failure origin.

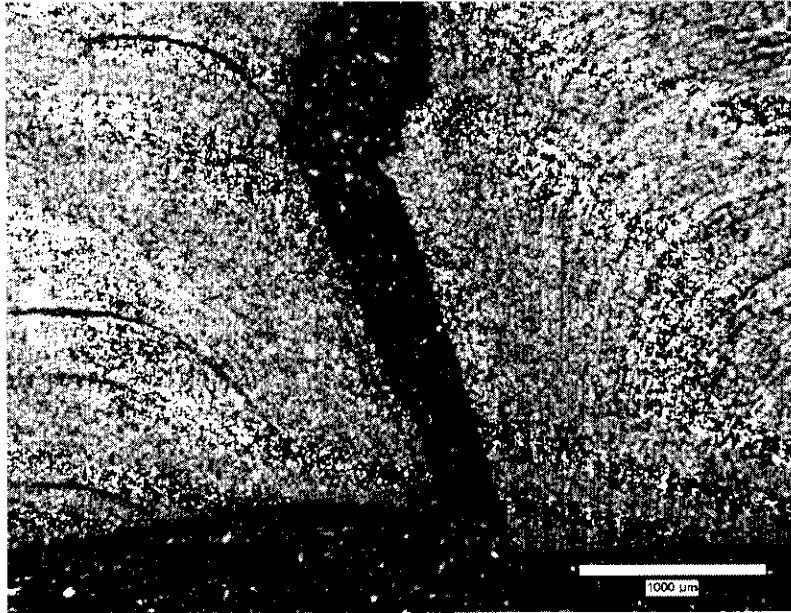
Figure 11 Joint No. 6105 25X
Hot Picric Acid Etch

View at higher magnification at the inside surface of the section shown in Figure 8 after etching.

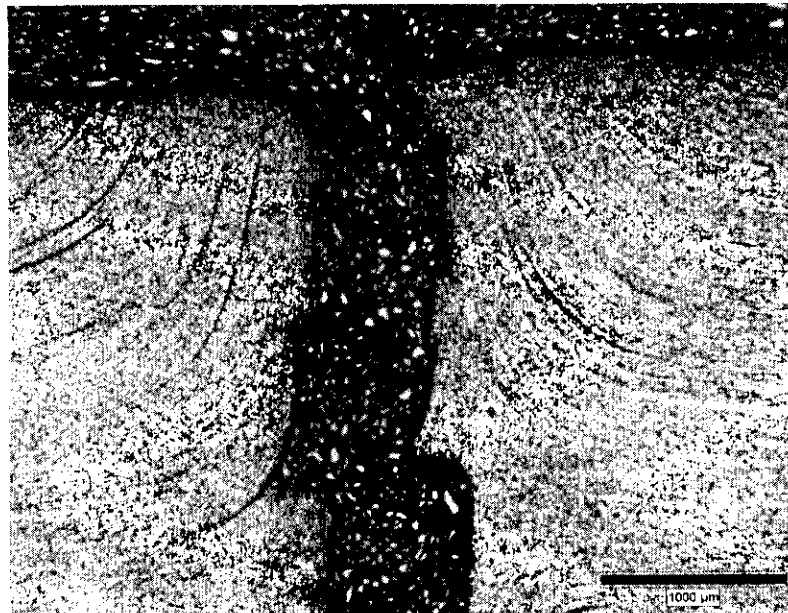
Figure 12 Joint No. 6105 25X
Hot Picric Acid Etch

View at higher magnification at the outside surface of the section shown in Figure 9 after etching.

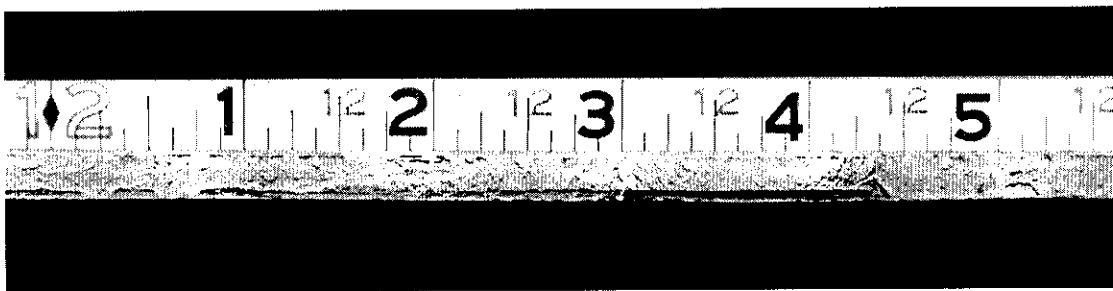
Figure 15

Photograph showing a long hook crack on the outside surface (at bottom).

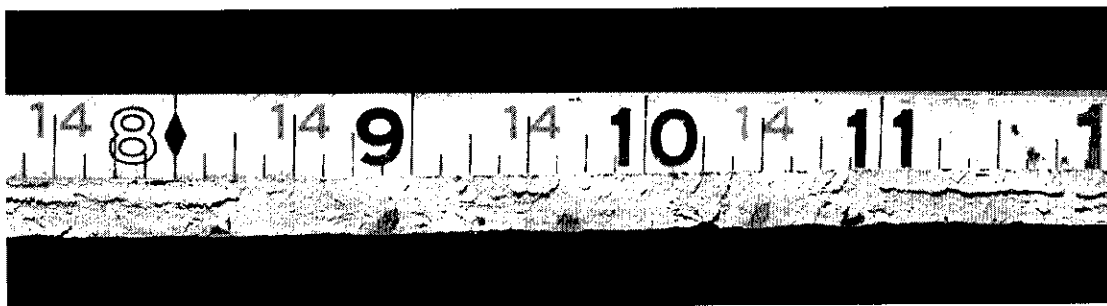
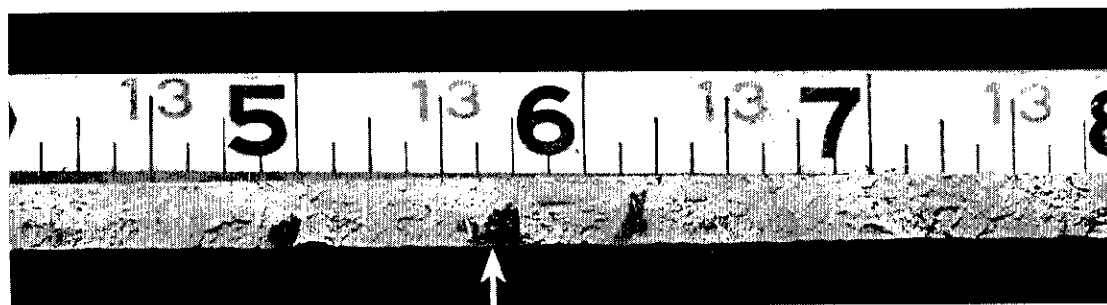
Photographs showing typical black spots on the outside surface (at bottom). The arrow in Figure 17 indicates the deepest flaw.

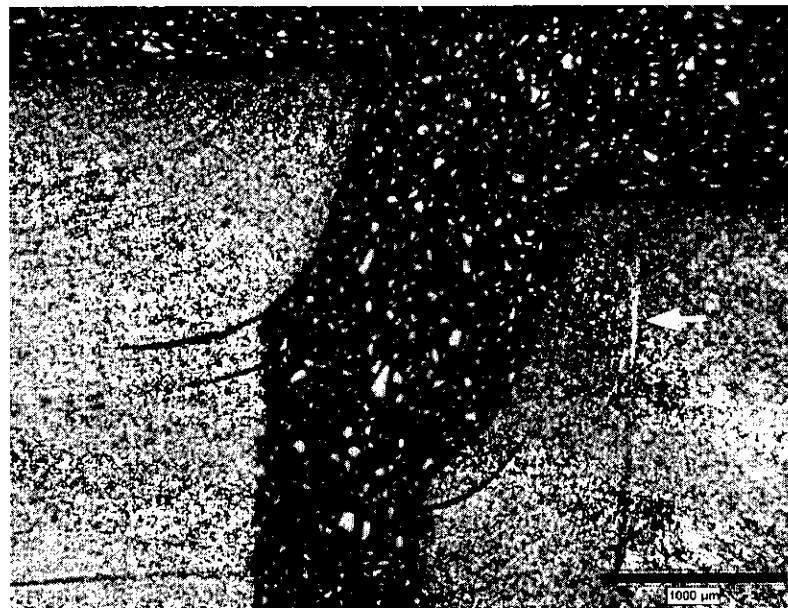
Figure 19 Joint No. 2797 25X
Hot Picric Acid Etch

Outside surface of the hook crack after etching. The arrow indicates the weld line.

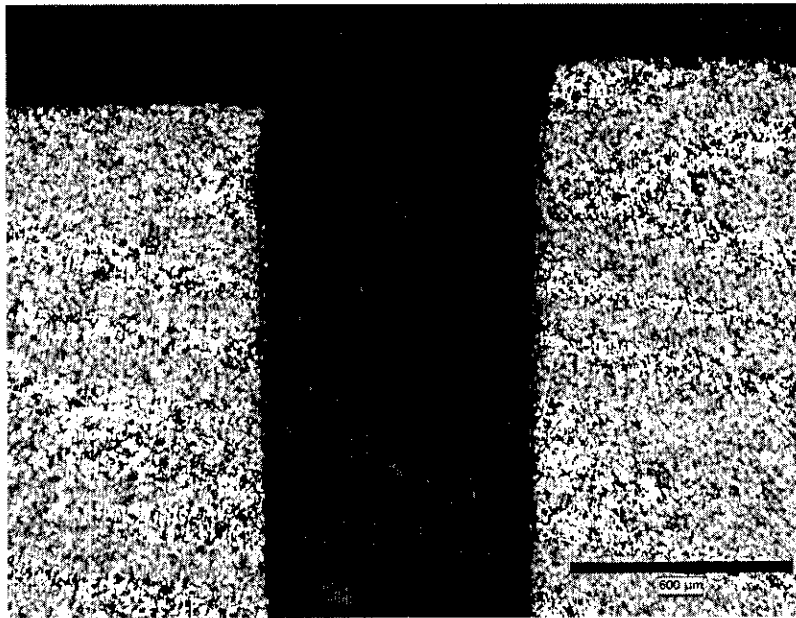
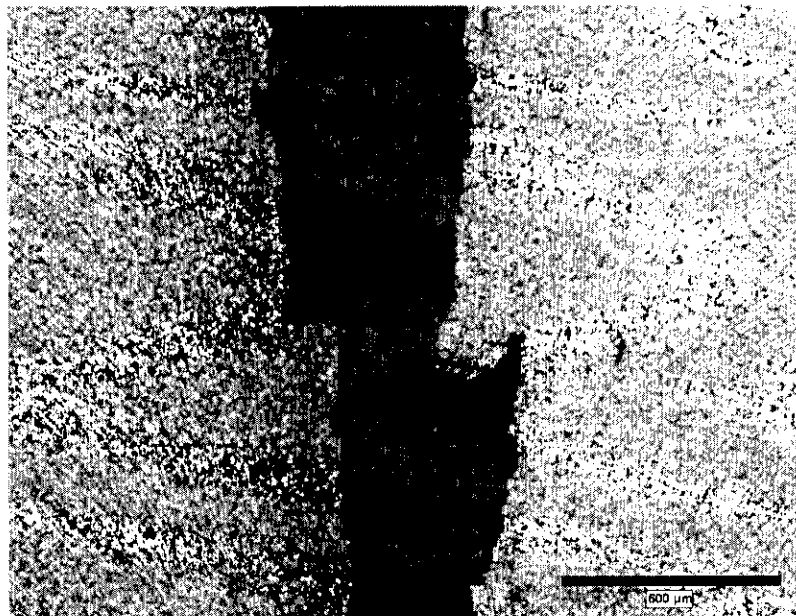
Photomicrographs showing the black spot at the outside surface, Figure 21, and near the inside surface, Figure 22.

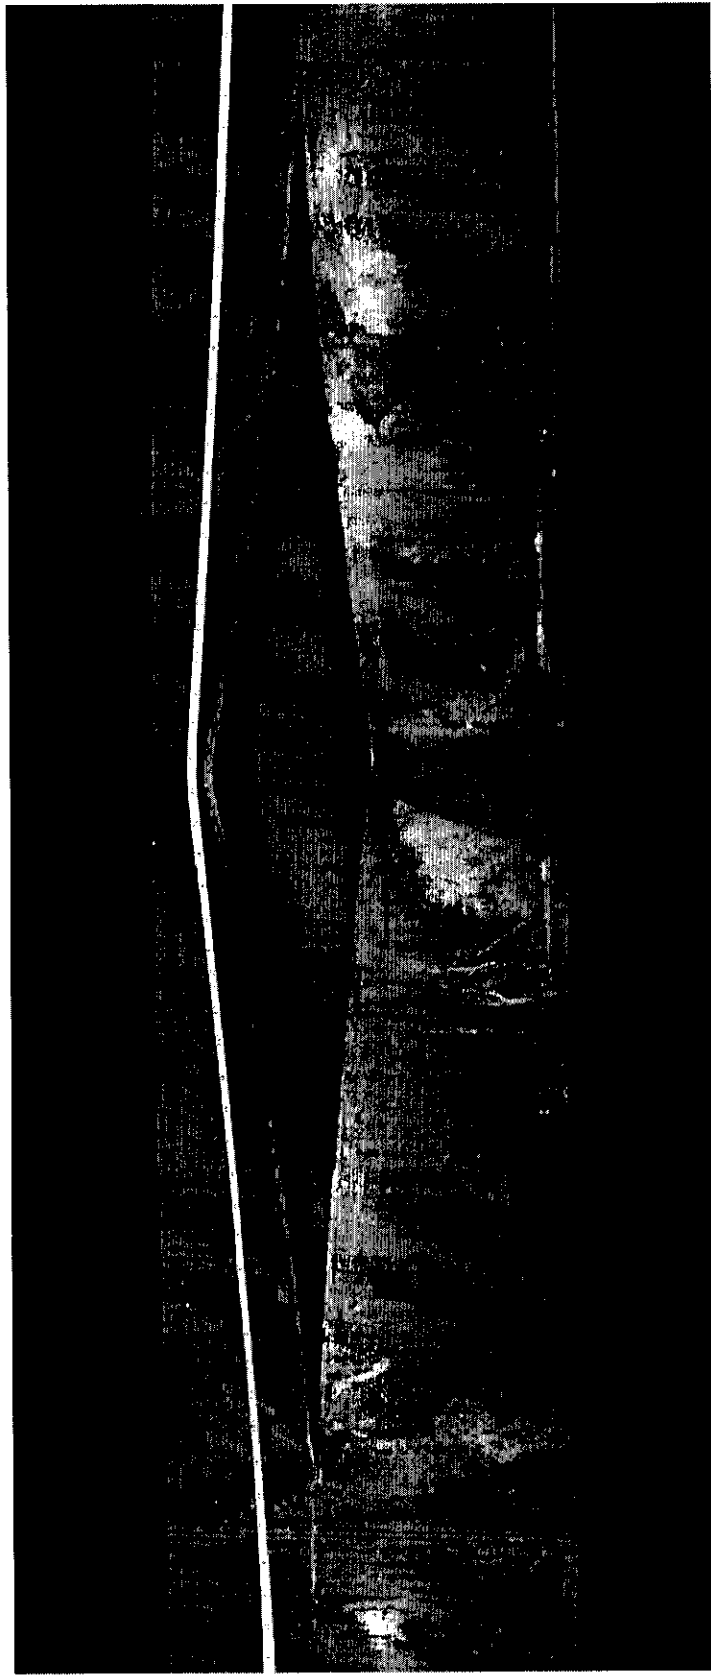
Figure 23

Photograph showing the rupture in Joint No. 324.

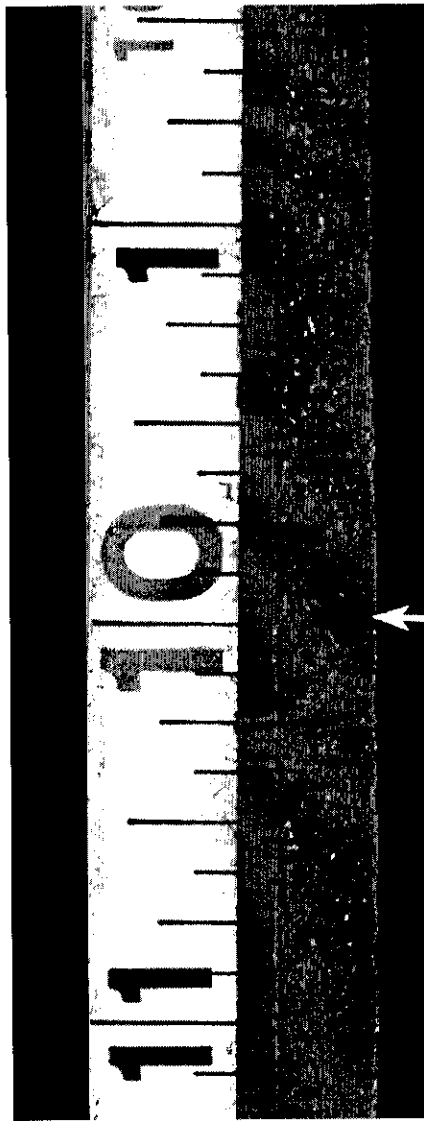
Photographs of a concentration of black spots on the outside surface, Figure 30, and of three black spots at a PAUT indication, Figure 31. The arrows indicate locations from which metallographic sections were taken.

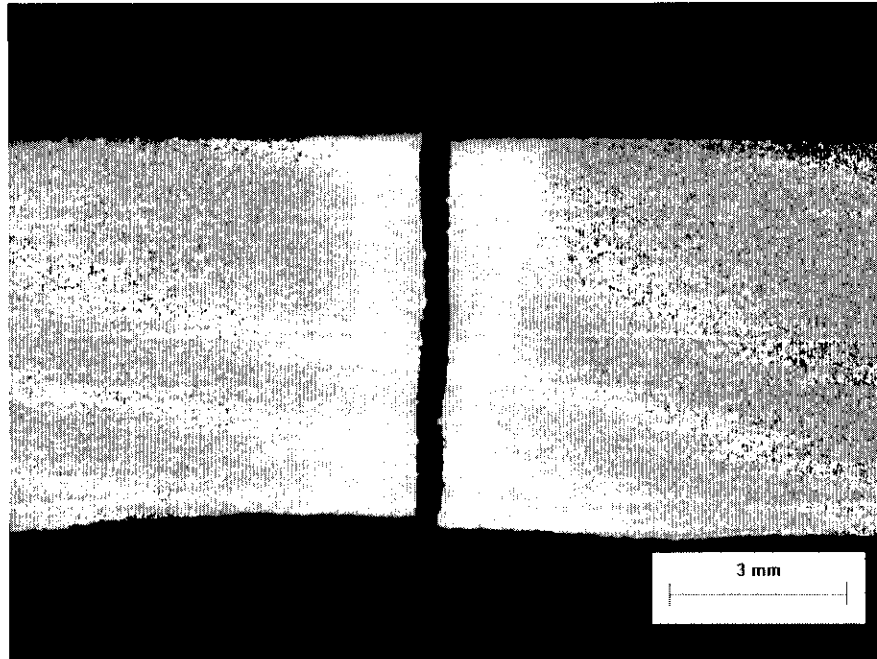
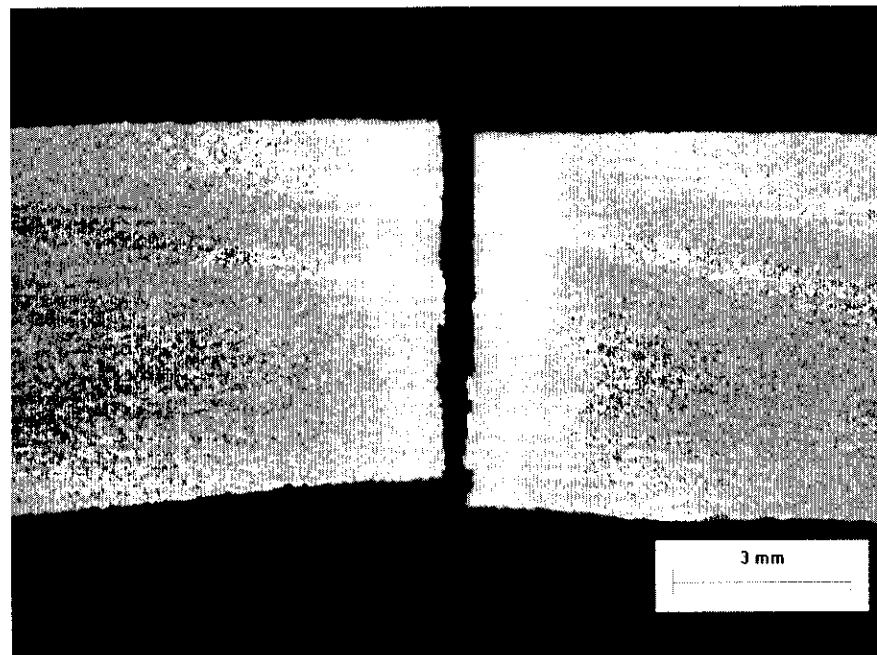
Photomicrographs showing the sections from the black spots shown in Figures 30 and 31, respectively.

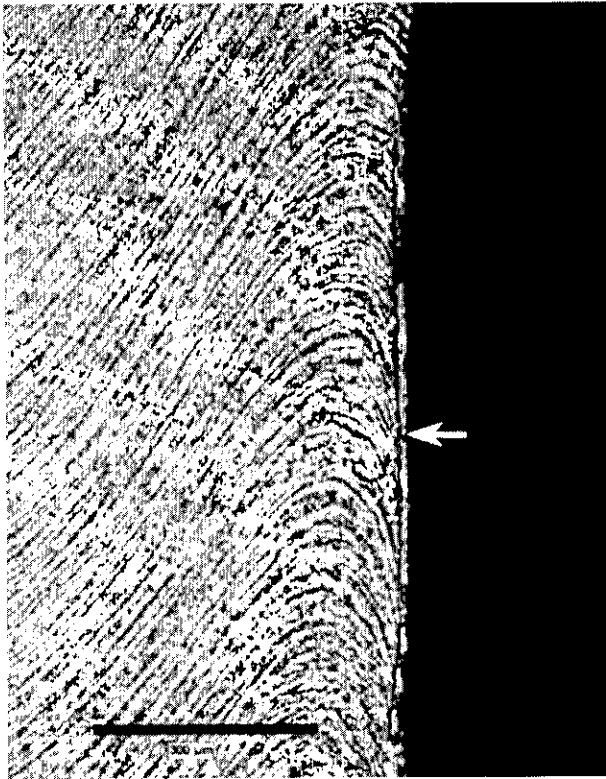
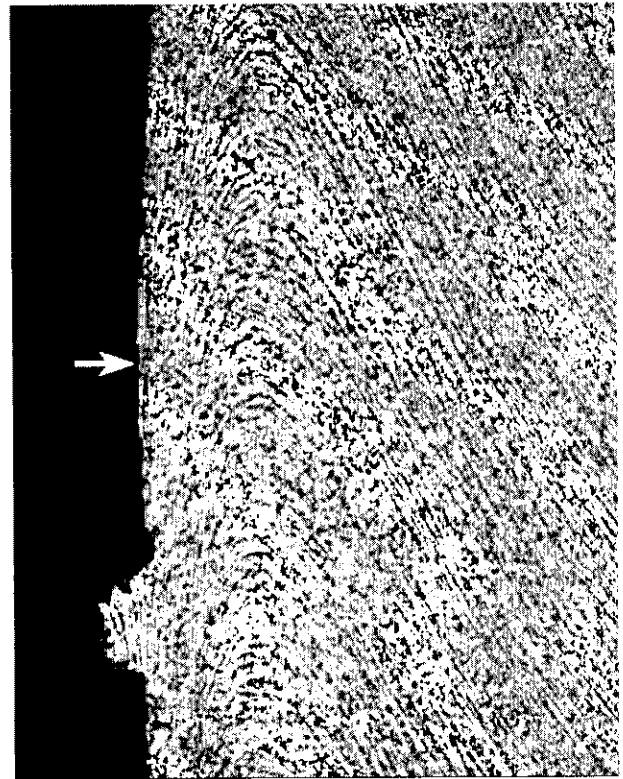
Photomicrographs showing a thin layer, arrows, along the surfaces of the black spot shown in Figure 30.

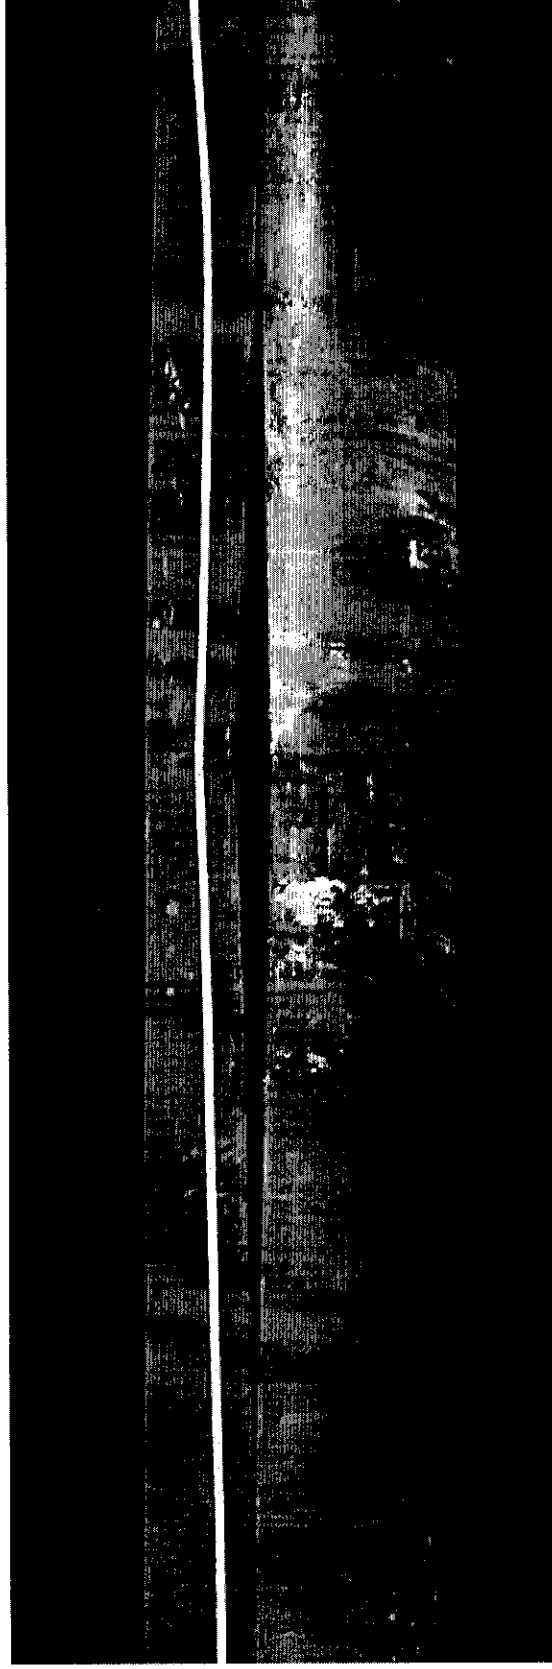
Figure 36

Photograph showing the rupture in Joint No. 6106.

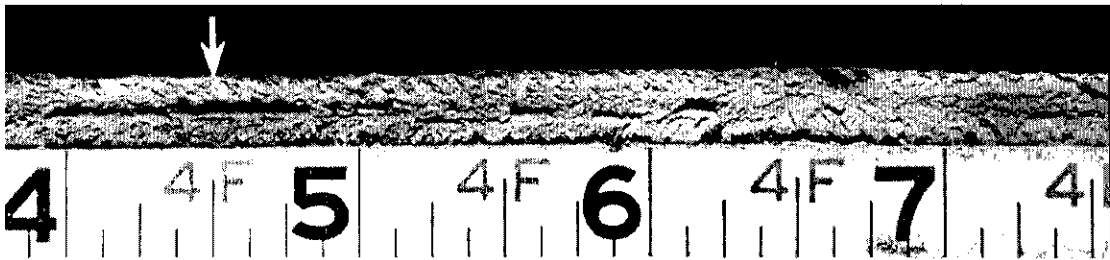
Figure 38

Photograph showing the fracture surface at a reported PAUT indication. The arrow indicates a location from which a metallographic section was taken.

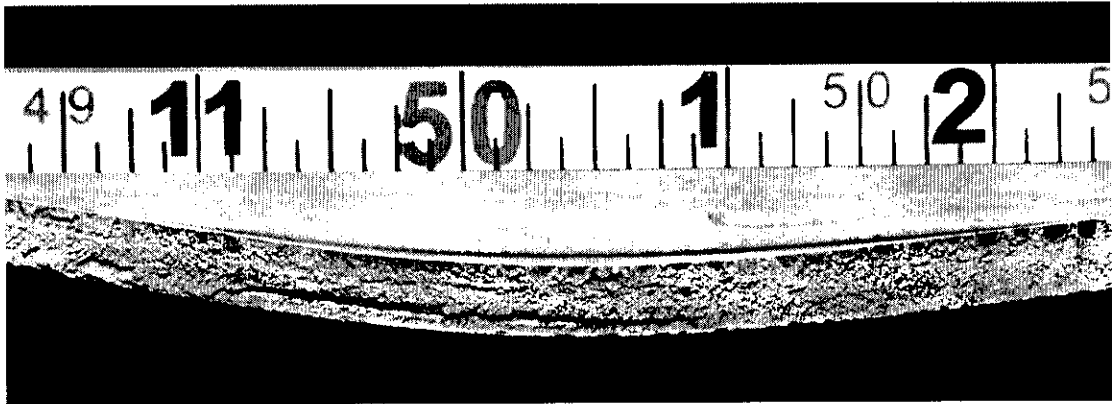
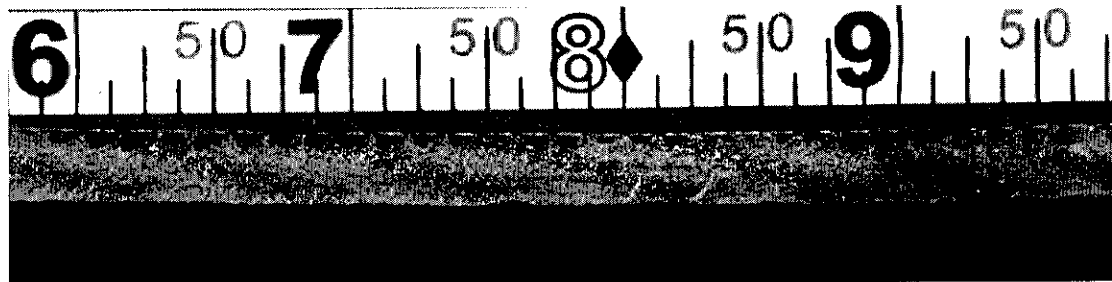
Figure 42 shows the hook crack at the outside surface at the failure origin, and Figure 43 shows typical black spots at the inside surface.

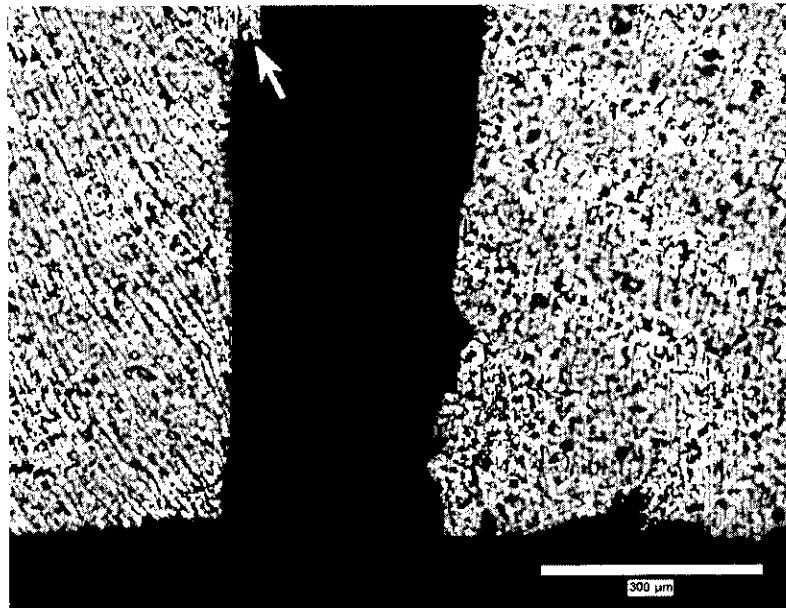
Figure 47 Joint No. 2796 100X
Nital Etch

Figure 46 shows the jagged fracture just above the black spot, and Figure 47 shows the smooth fracture along the black spot, which was never fused. The arrows indicate the top of the black spot.

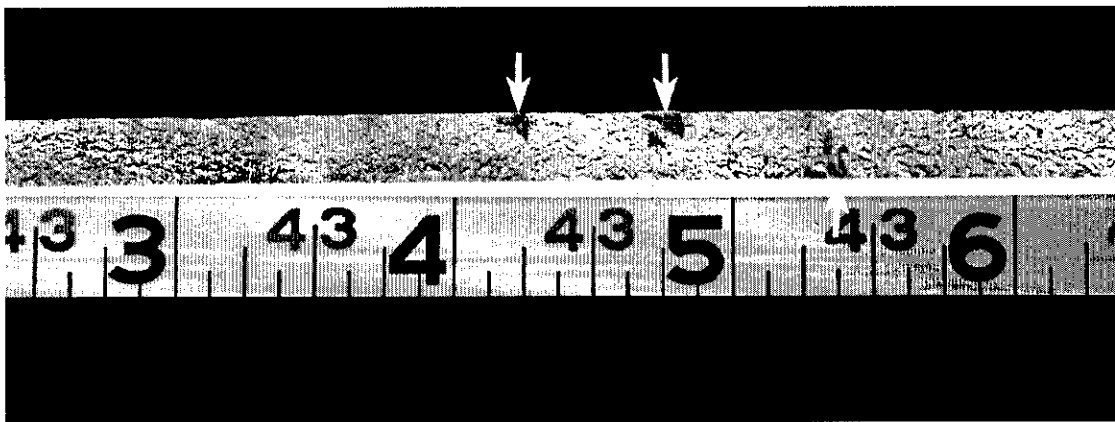
The rupture in Joint No. 6102, shown in Figure 48, was 7 feet, 9 inches long and extended to within one inch of the downstream girth weld. The fracture surface was, for the most part, flat and brittle with small black spots and small hook cracks scattered along the length. The deepest flaw was at a black spot at 43 feet, 5 inches, shown in Figure 49 with other black spots nearby, and was 54 percent of the wall thickness deep. There were two USCD features reported within the fracture length, one 25 to 40 percent of the wall thickness deep at 39 feet, 1 inch, and one less than 12.5 percent of the wall thickness deep at 44 feet, 2 inches. As shown in Figure 50, no defect was apparent at 39 feet, 1 inch; the flat, brittle fracture at this location is typical of most of the fracture surface. Figure 51 shows shallow hook cracks at 44 feet, 2 inches, where the shallow USCD indication was reported.

Matching transverse sections were taken from the black spot at the 43 feet, 5 inch mark in Figure 49, and across the hook crack near the 44 feet, 2 inch mark in Figure 51. Figures 52 and 53 show the sections after polishing and etching. Note the heat-affected zones that show this joint either was not manufactured by Lone Star Steel, or was not full-body normalized after welding. The fracture along the black spot was straight and flat, as shown in Figure 54. Note that the fibers on each side of the fracture are reverse bent so that they turn back down at the weld instead of turning toward the outside surface. A thin layer of scale can be seen on the fracture at left, and a thin layer of decarburized (light-etching) metal can be seen on the fracture at right.

Photograph showing black spots, arrows at the inside and outside surfaces. The deepest flaw was at the arrow near 43 feet, 5 inches.

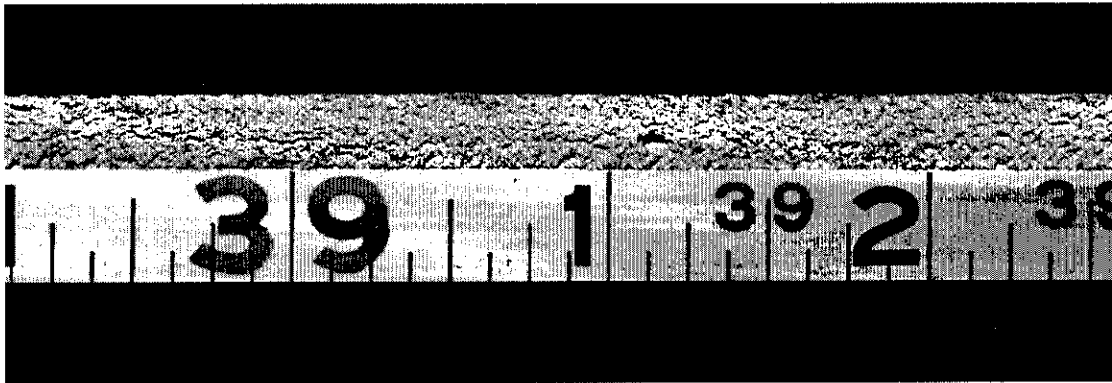
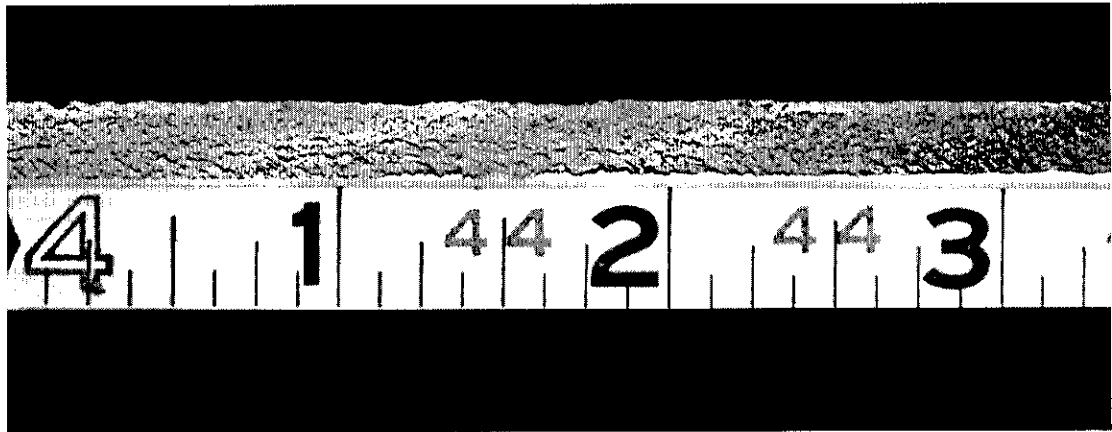
Photographs showing the fracture surface at the two reported USCD indications.

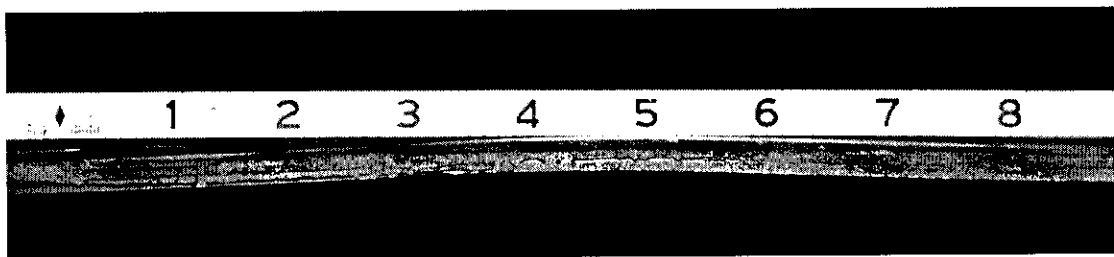
The rupture in Joint No. 2753, shown in Figure 55 was 10 feet, 9 inches long and opened less than an inch at the widest point. The fracture surfaces were rough and irregular for most of the length, with long hook cracks apparent at several locations. The most likely failure origin was at a long hook crack at the outside surface near the middle of the rupture where a 4.9-inch long USCD indication was reported. Figure 56 shows the hook crack that extended approximately from 32 feet to 32 feet, 8 inches; the USCD indication was reported at 32 feet, 4 inches

(32.32 feet). The depth of the flaw at the origin was 59 percent of the wall thickness. Figures 57 and 58 show another representative location.

Photograph showing a long hook crack at the outside surface at the failure origin. A USCD indication was reported at 32 feet, 4 inches.

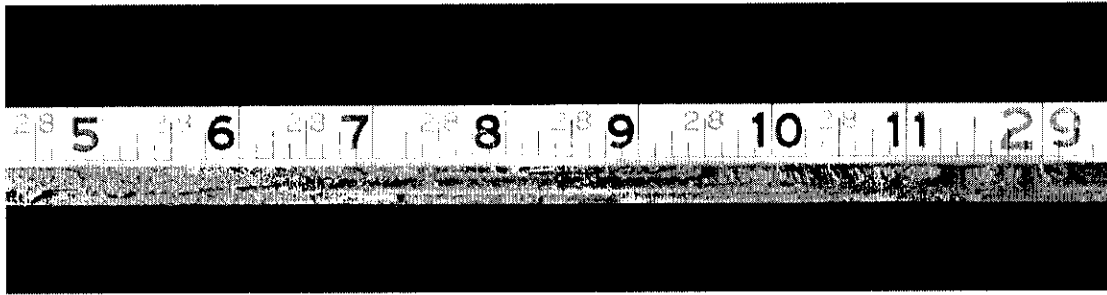
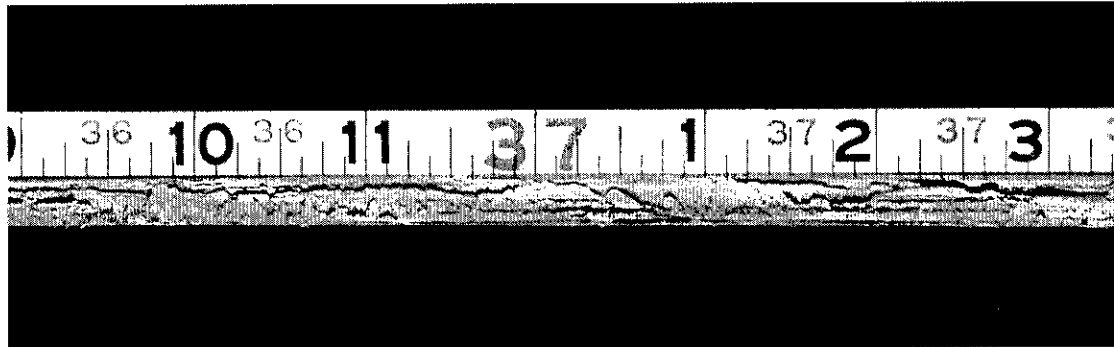
Figure 57 shows a typical location with hook cracks and multilayer fracture surface, and Figure 58 is a closer view of part of the fracture.

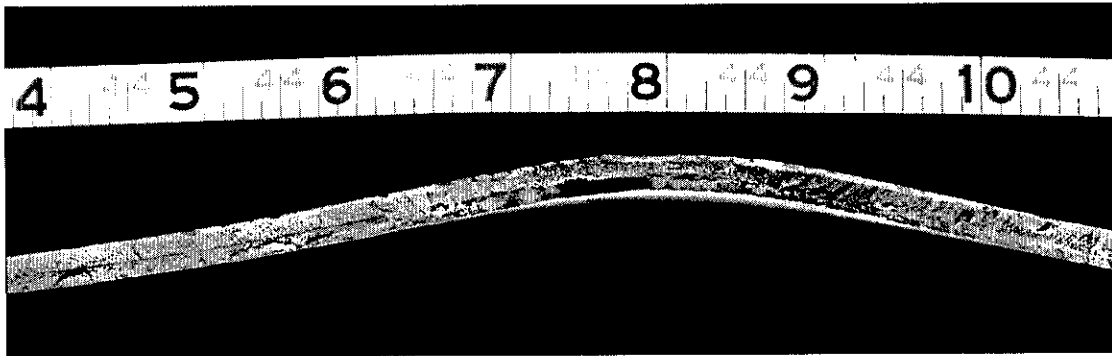
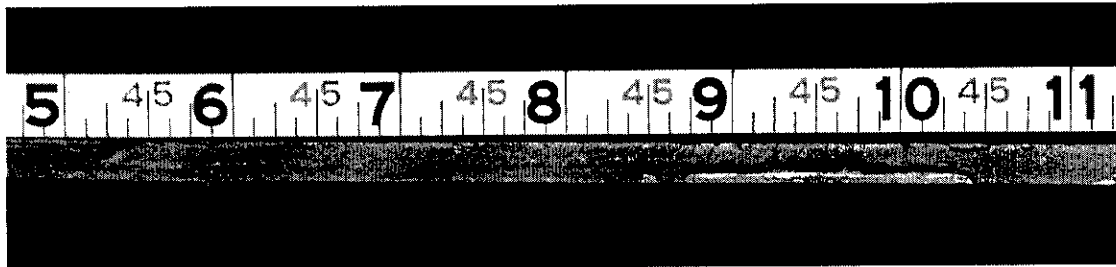
Joint No. 4013, shown in Figure 60, ruptured for a length of 4 feet, 11 inches. The apparent origin was at a hook crack located at a bulge near the middle of the rupture, centered at 44 feet, 8 inches, as shown in Figure 61. The depth of the hook crack was 44 percent of the wall thickness. The rest of the fracture was mostly flat and brittle, with apparent flaws on the inside surface at a few locations. A USCD indication was reported at 45 feet, 7 inches (45.6 feet). As shown in Figure 62, there appeared to be a large hook crack or other flaw at the inside surface at that location.

Figure 61 shows a hook crack on the inside surface at the failure origin, and Figure 62 shows the fracture at the location of a reported USCD indication (45 feet, 7 inches).

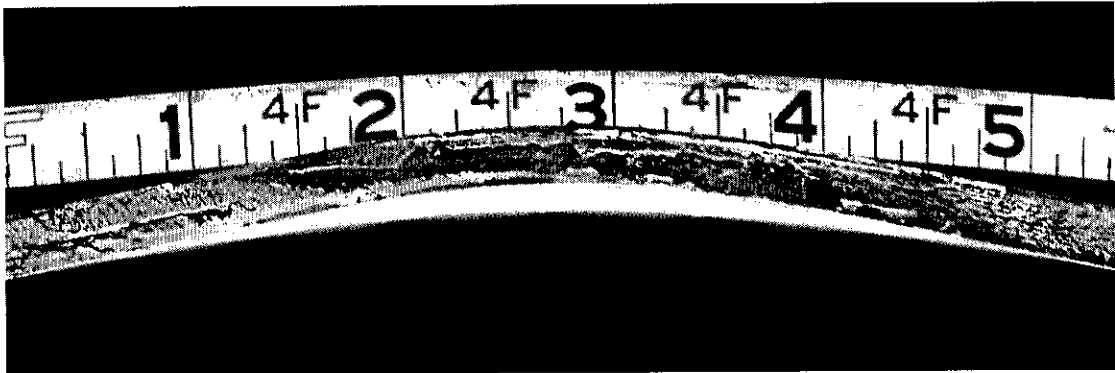
Figure 65

Joint No. 6418, shown in Figure 64 ruptured near one end of the joint, for a length of 4 feet, 8 inches. The apparent fracture origin was at a bulge at 4 feet, 3 inches, shown in Figure 65. There appeared to be flaws at both the inside and outside surfaces, the combined depths of which were approximately 60 percent of the wall thickness. There were no inspection indications reported in the fracture length. The rest of the fracture was mostly flat and brittle, with hook cracks apparent at a few locations. Figure 66 shows a location with a long hook crack near midwall.

Photograph of the apparent fracture origin.

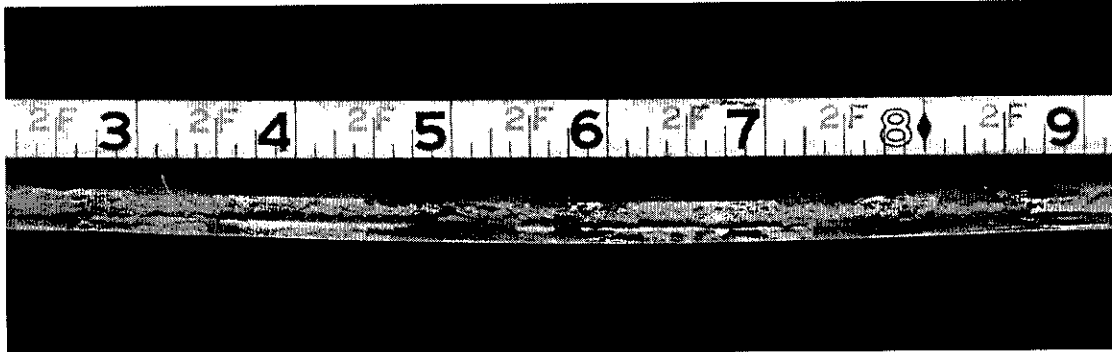
Figure 66

Photograph showing a typical location with hook cracks and brittle fractures.

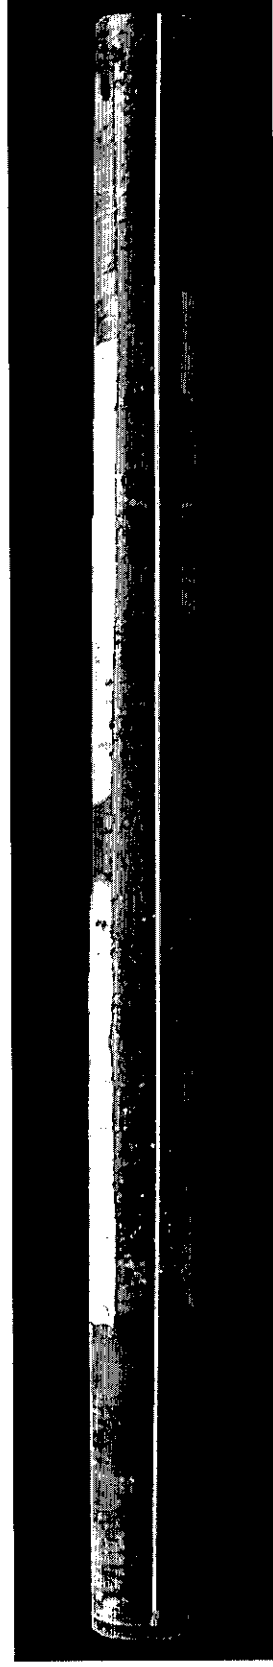
Joint No. 10737 been wrapped with Polyguard and a strip of the coating had to be removed to examine the rupture. Figure 68 shows the pipe after the strip was removed from each side of the rupture, which was 8 feet, 1 inch long. The fracture surface contained a large number of hook cracks along the length of the rupture, with brittle fractures in between. The failure origin was not apparent but likely was at one of the hook cracks. Manual and PAUT inspection indications were reported at 5 feet, 6 feet, 5 inches (6.4 feet), 6 feet, 7 inches (6.6 feet) and 8 feet. The indication at 5 feet was reported to be 10.93 inches long and 36 percent of the wall thickness deep. Our examination showed the deepest flaw, 50 percent of the wall thickness, to be at 5 feet, 8.5 inches, shown in Figure 69. The fractures at the other two reported indications contained large hook cracks, as shown in Figures 70 and 71.

Photograph showing the rupture in Joint 10737.

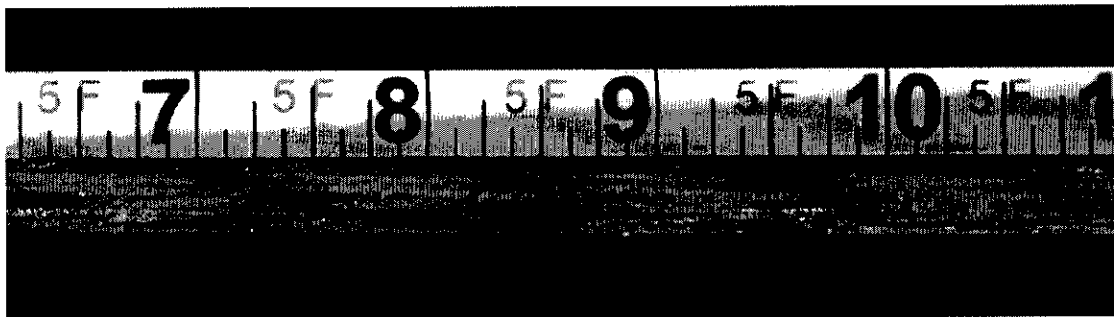
Figure 69

Photograph of the fracture at the deepest flaw, which was in the middle of a long USCD reported indication.

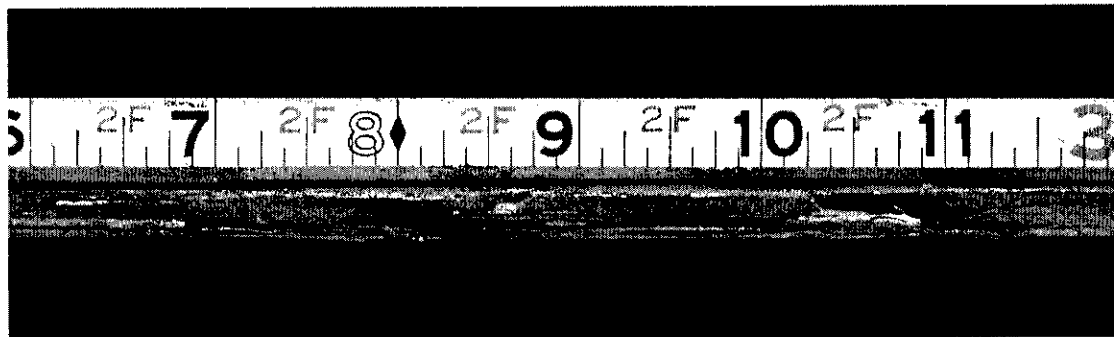
Figure 70

Photographs showing hook cracks on the fracture surface at the other two reported USCD indications.

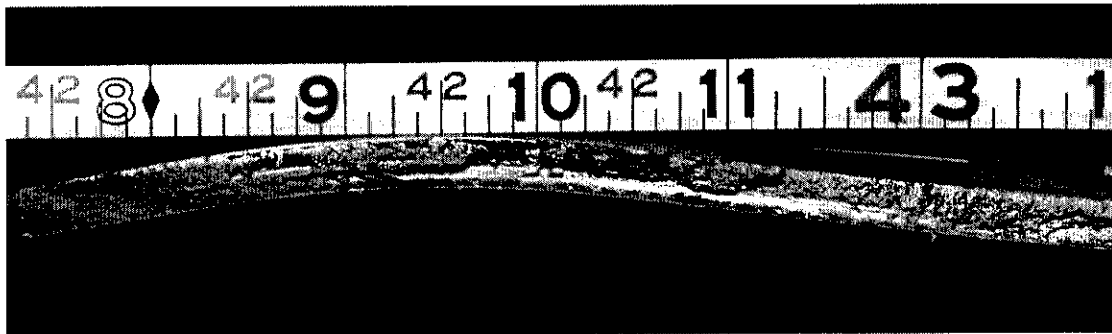
Joint No. 7757

Photograph showing the rupture in Joint No. 7757.

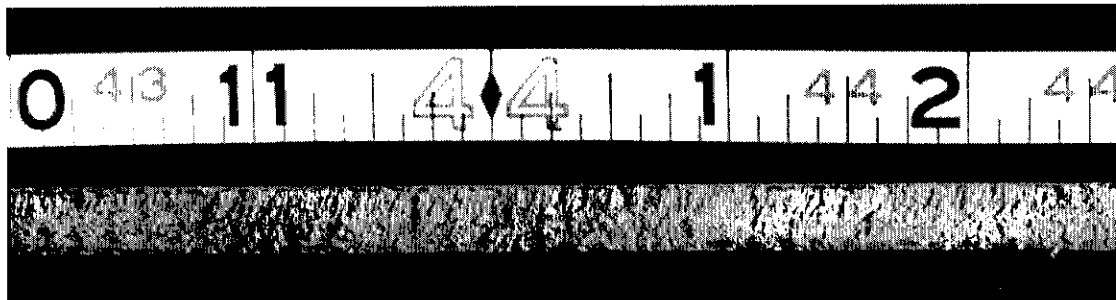
Figure 74

Photograph showing the fracture at the failure origin.

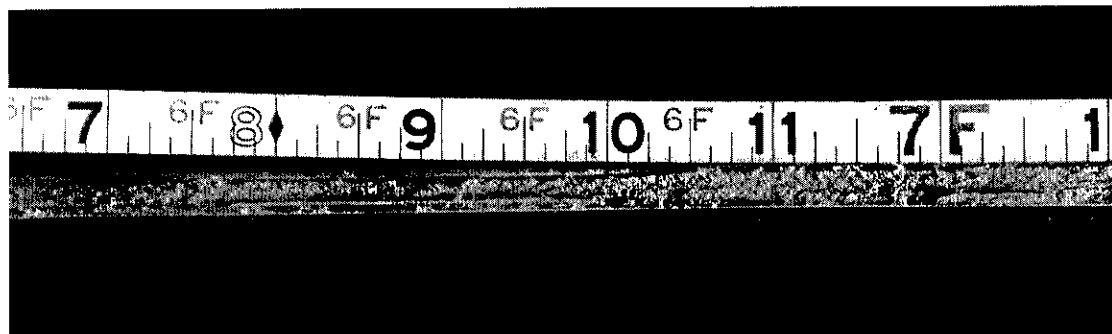
Figure 78 shows the fracture at the failure origin, and Figure 79 shows a typical area of brittle fracture and hook cracks.

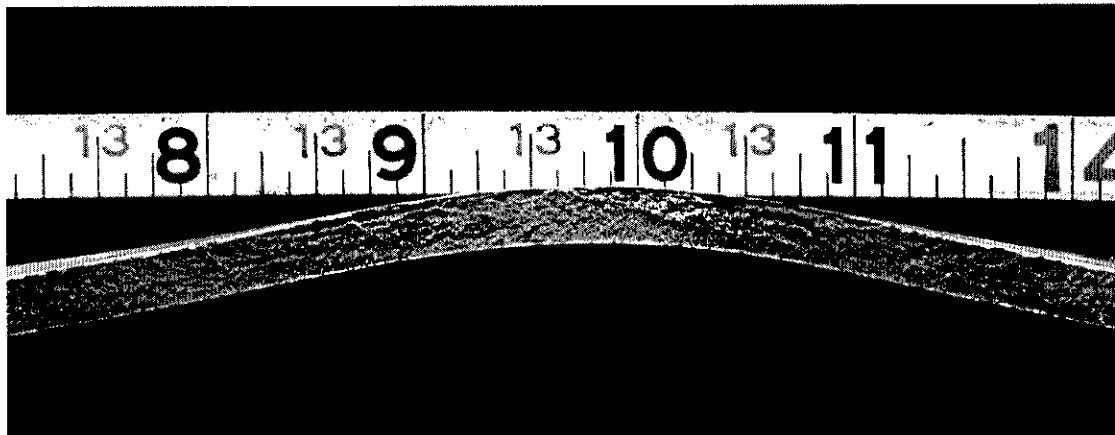
Figure 89 shows chevrons pointing toward the failure origin, and Figure 90 is a closer view of the origin.

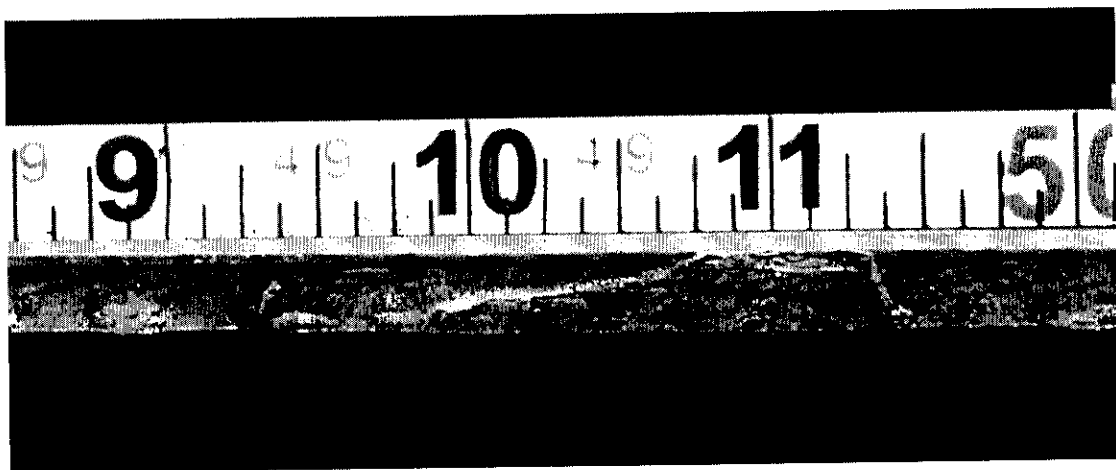
Figure 99 shows the deepest flaw and likely failure origin, and Figure 100 shows part of a hook crack within the length of a reported USCD indication.

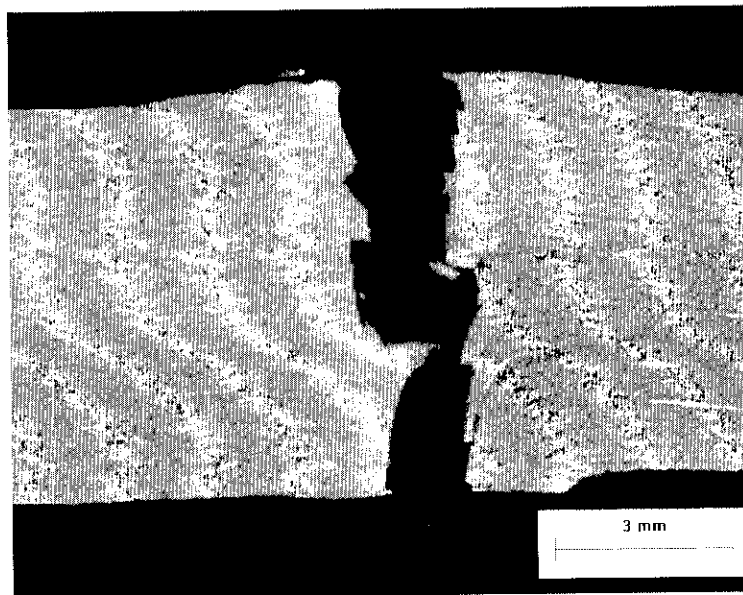
Figure 101 Joint No. 2405 8X
Nital Etch

Matching transverse sections from the hook crack at the suspected failure origin.

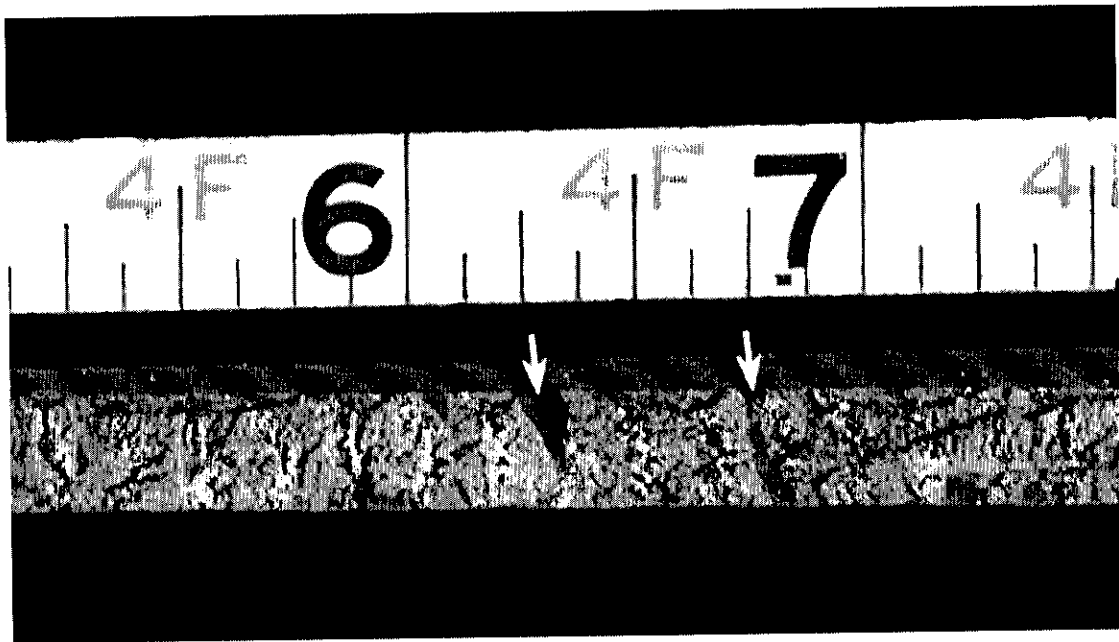
Figure 106 shows a hook crack, multilayered fracture and black spots at a bulge near the center of the rupture, and Figure 107 shows the deepest flaws, arrows, found along the rupture.

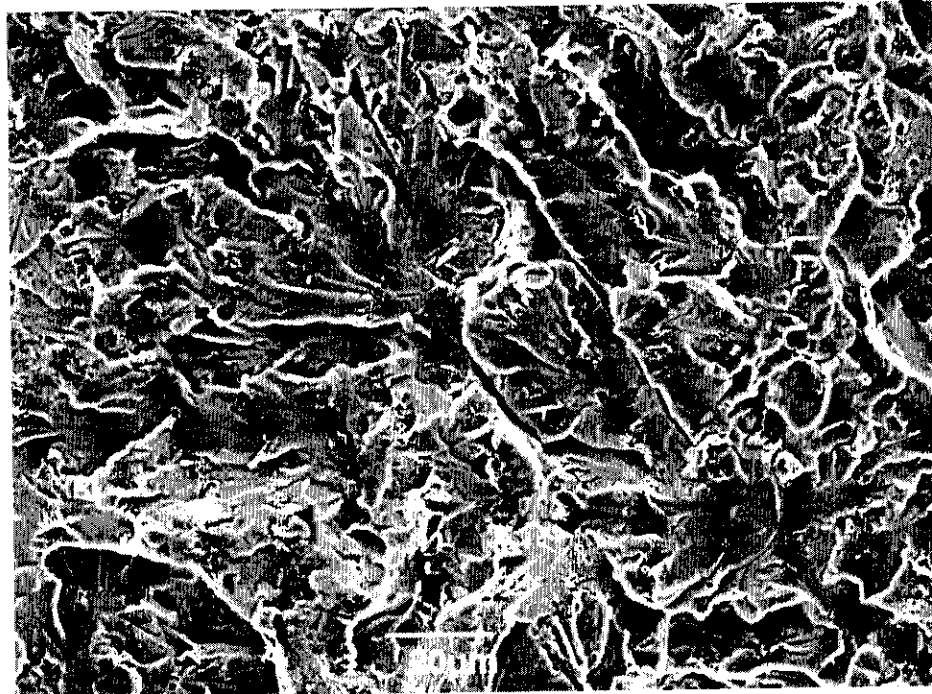
Figure 110 shows the area in the box at top and Figure 111 shows the area in the lower box in Figure 109 at higher magnification.
